① BUREAU OF SHIPS GROUP
TECHNICAL INSPECTION REPORT

(6) OPERATION CROSSROADS.

FAILURES OF MASTS, YARDARMS,
BOOMS AND RIGGING [U.]

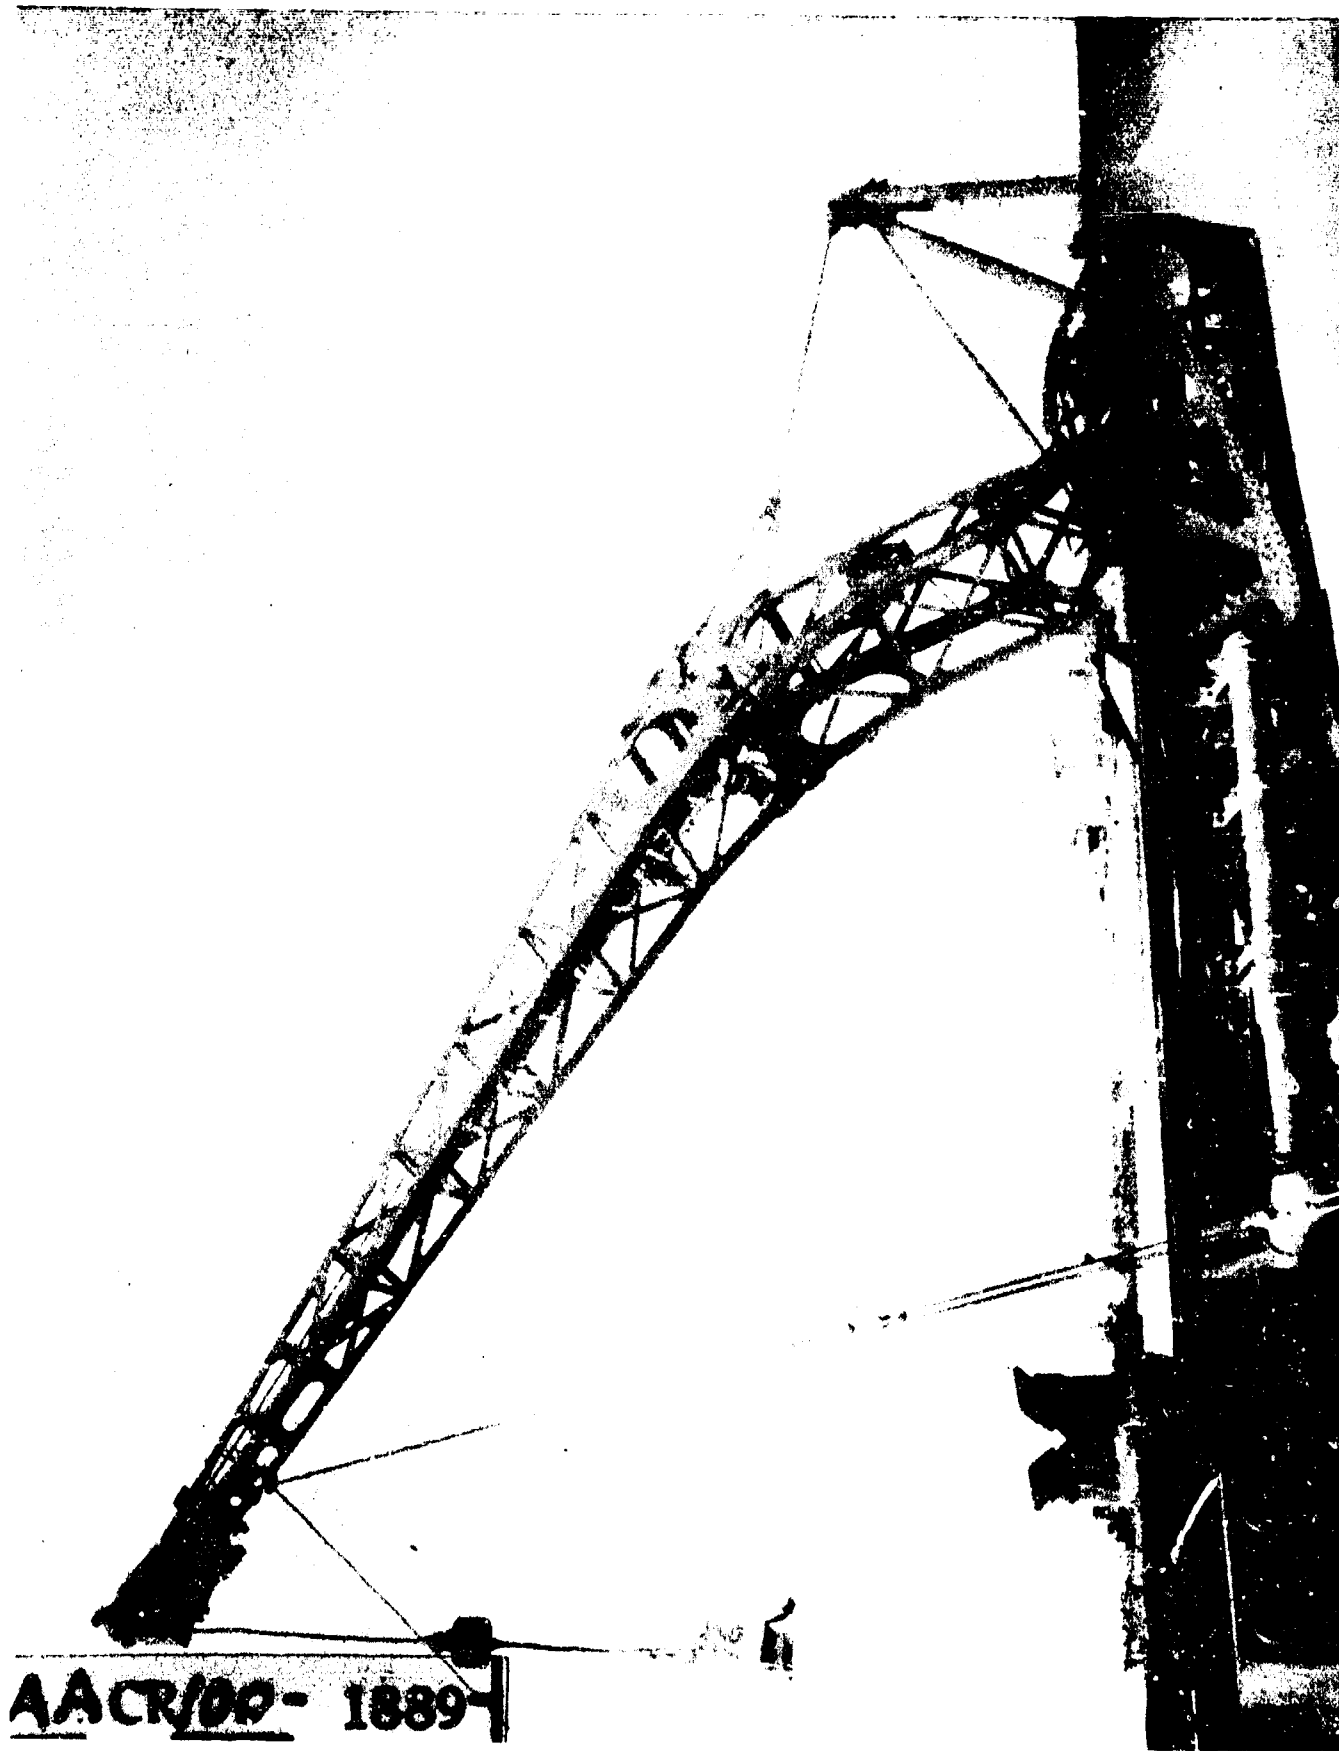
AA-CR-100-1889-9

AA-CR-100-1889-9. USS NEVADA (BB36). Stern crane, showing lower section knuckled and resting on catapult. Looking aft and to starboard.

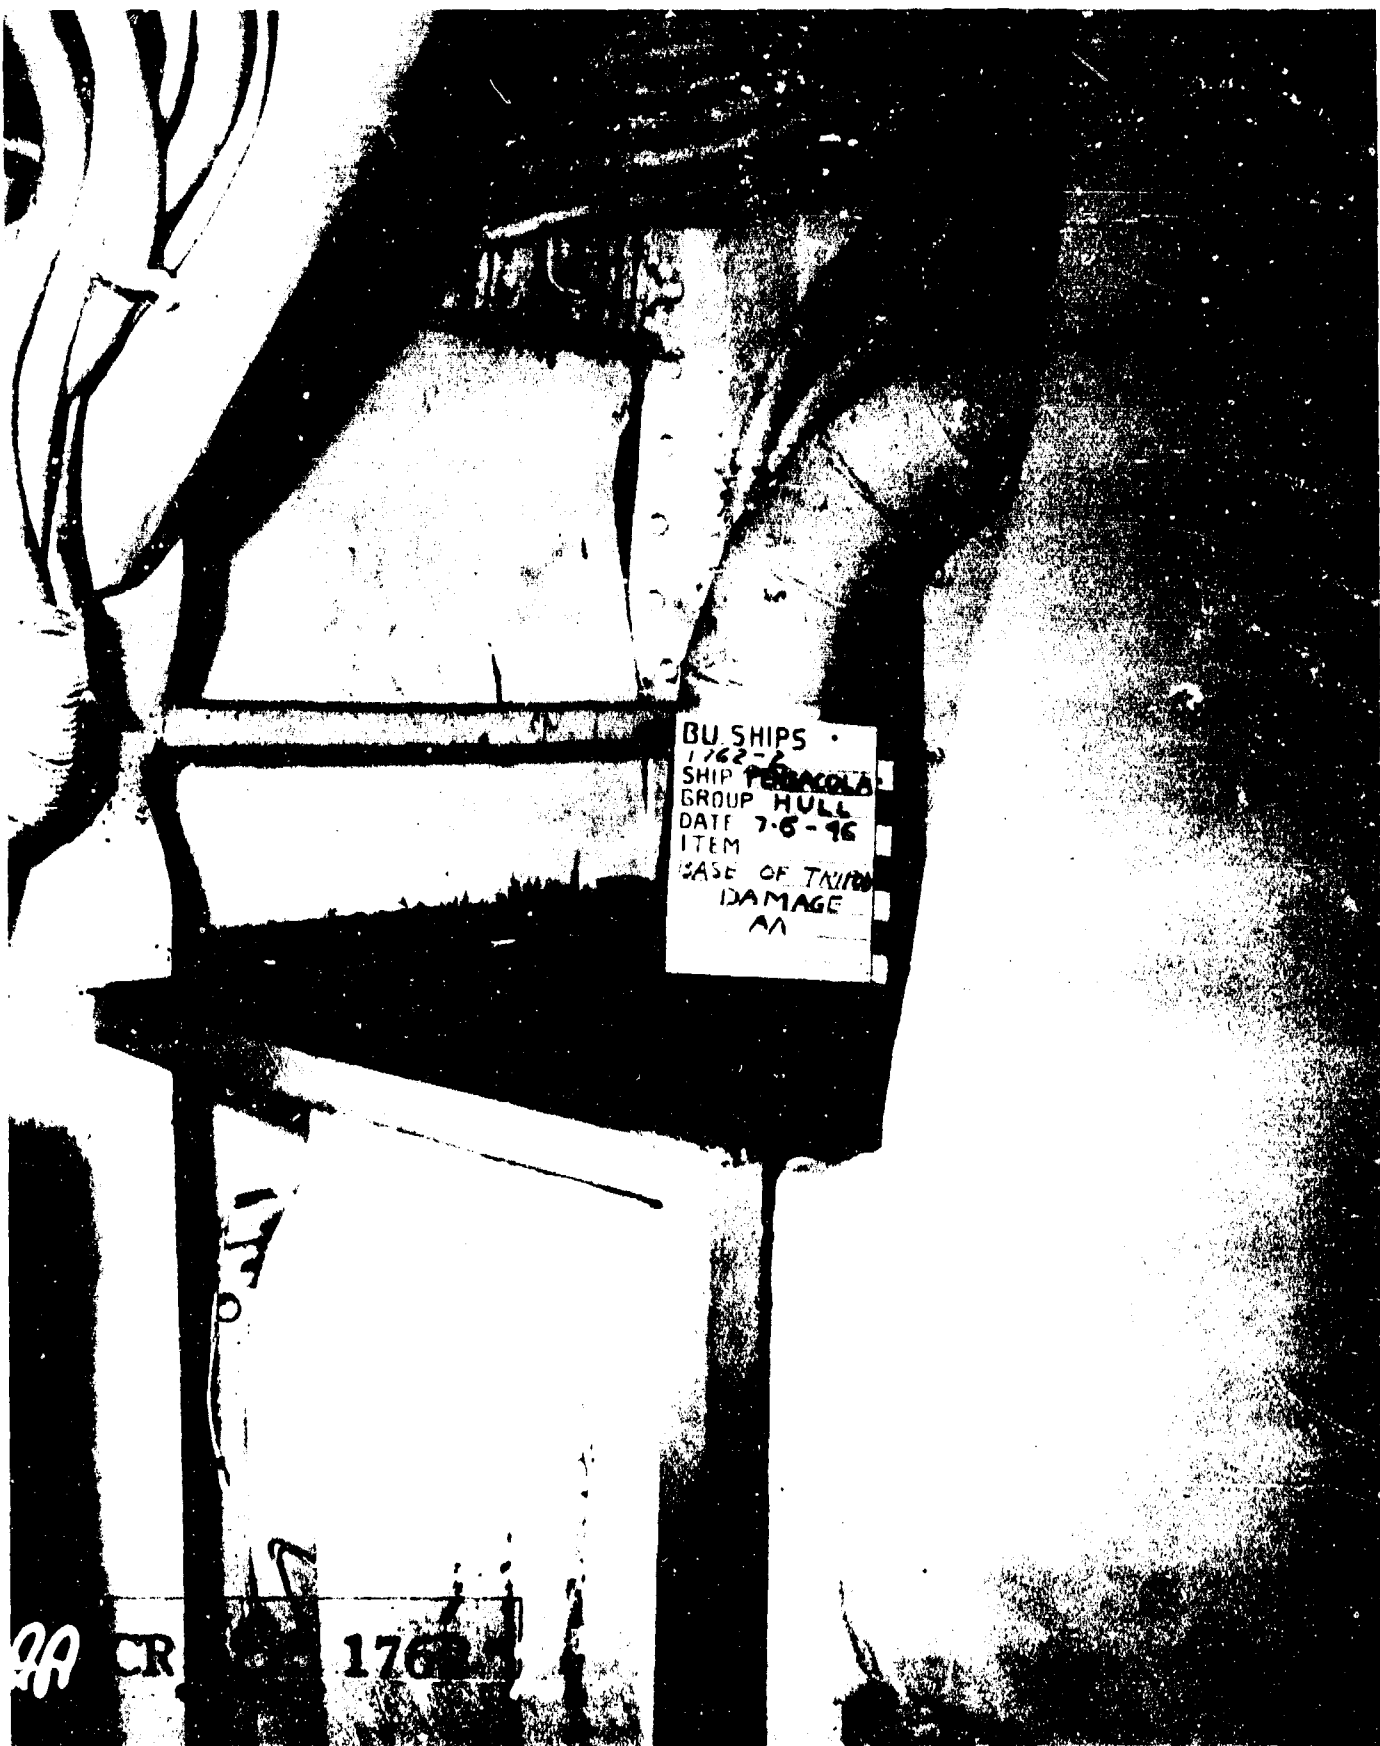
AA-CR-68-1762-2. U.S.S. PENSACOLA (CA24). bulkhead No. 42, showing crushing at centerline under forward leg of forward tripod. Looking aft from starboard side.

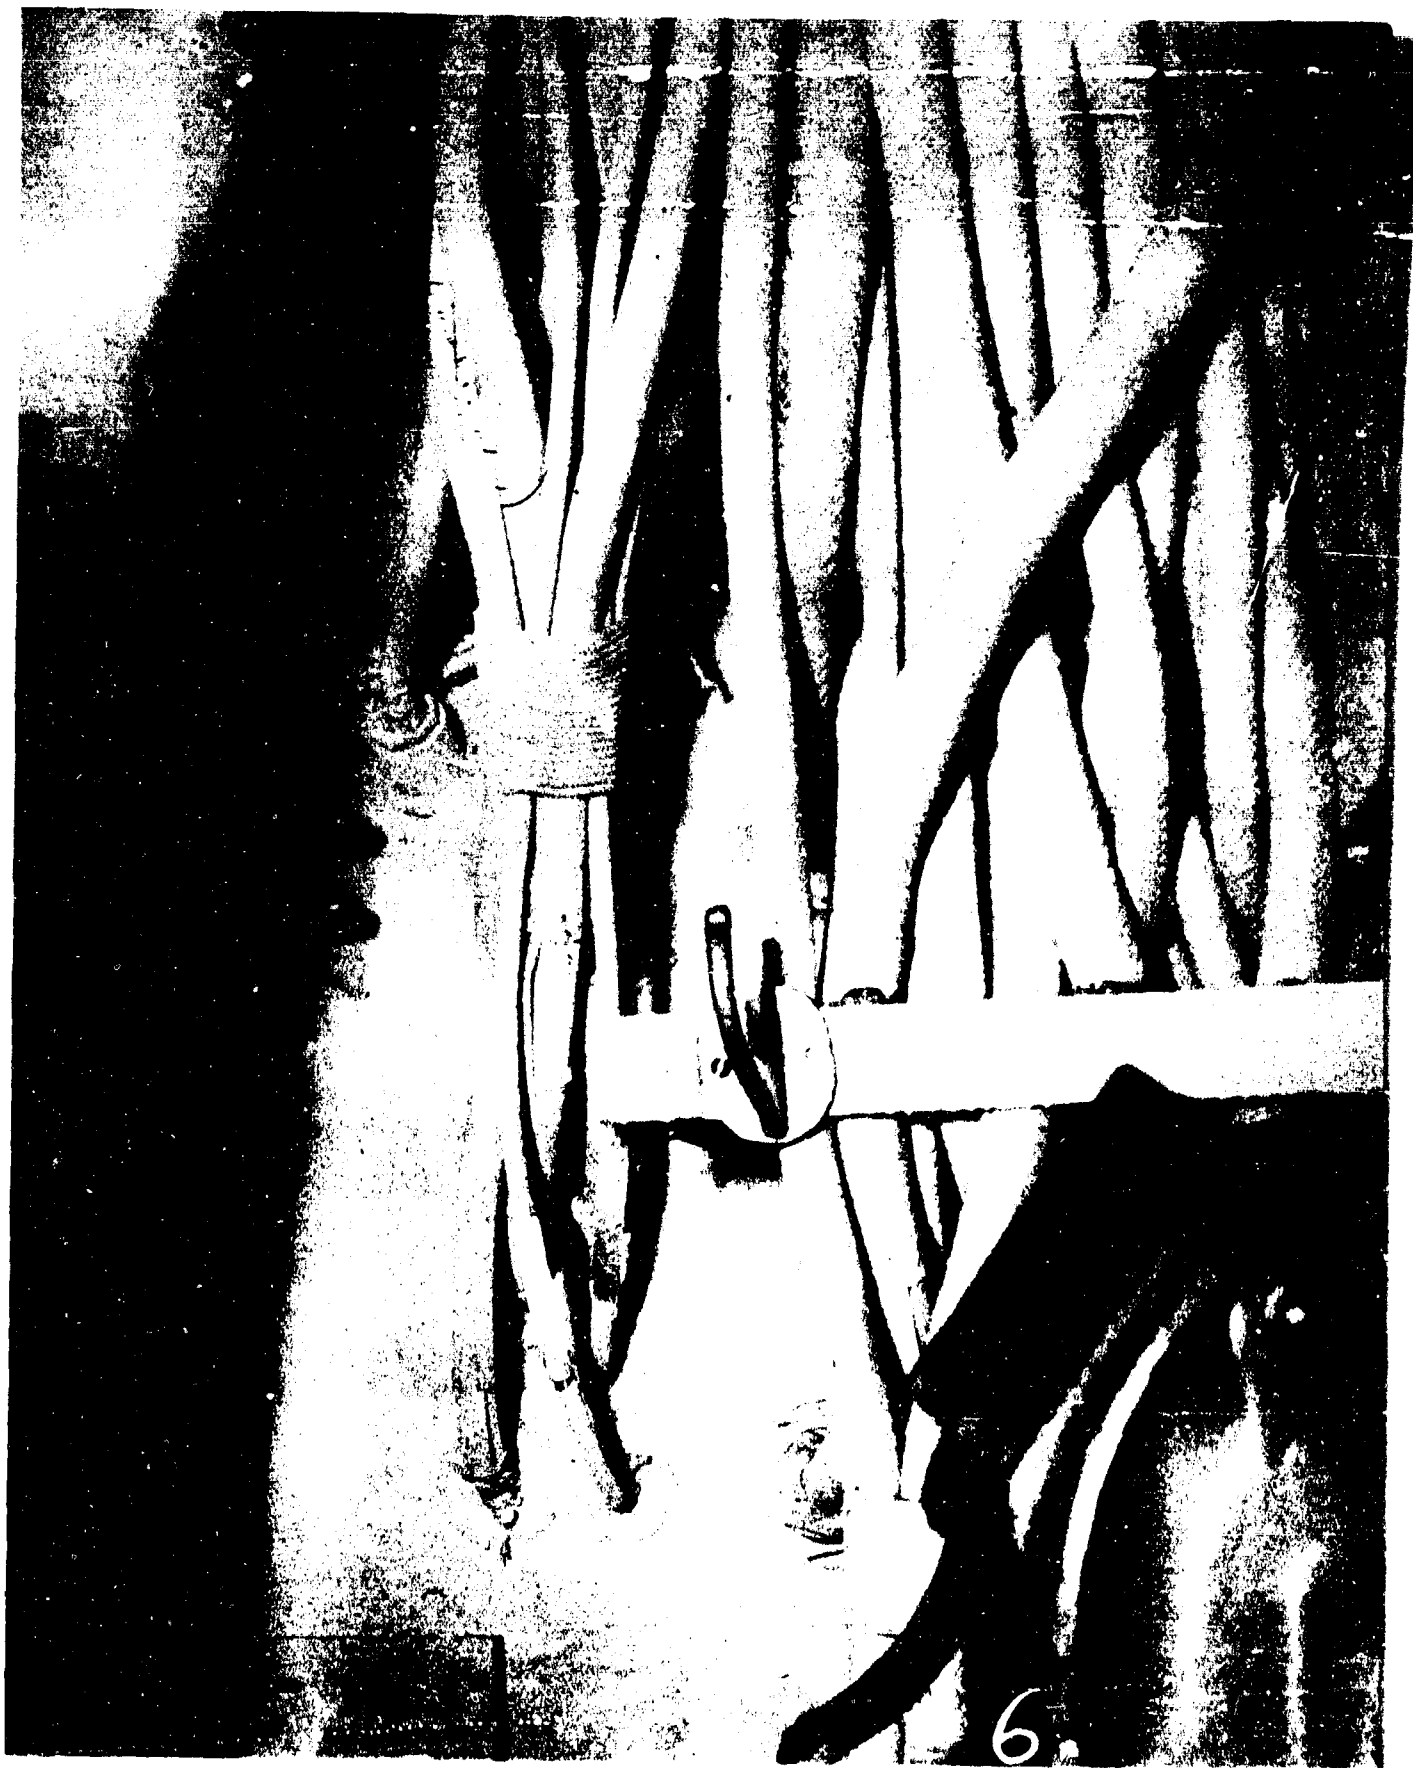
AA-CR-68-1763-6. U.S.S. PENSACOLA (CA24). Bulkhead No. 42, looking forward at centerline of ship between first and second platform.

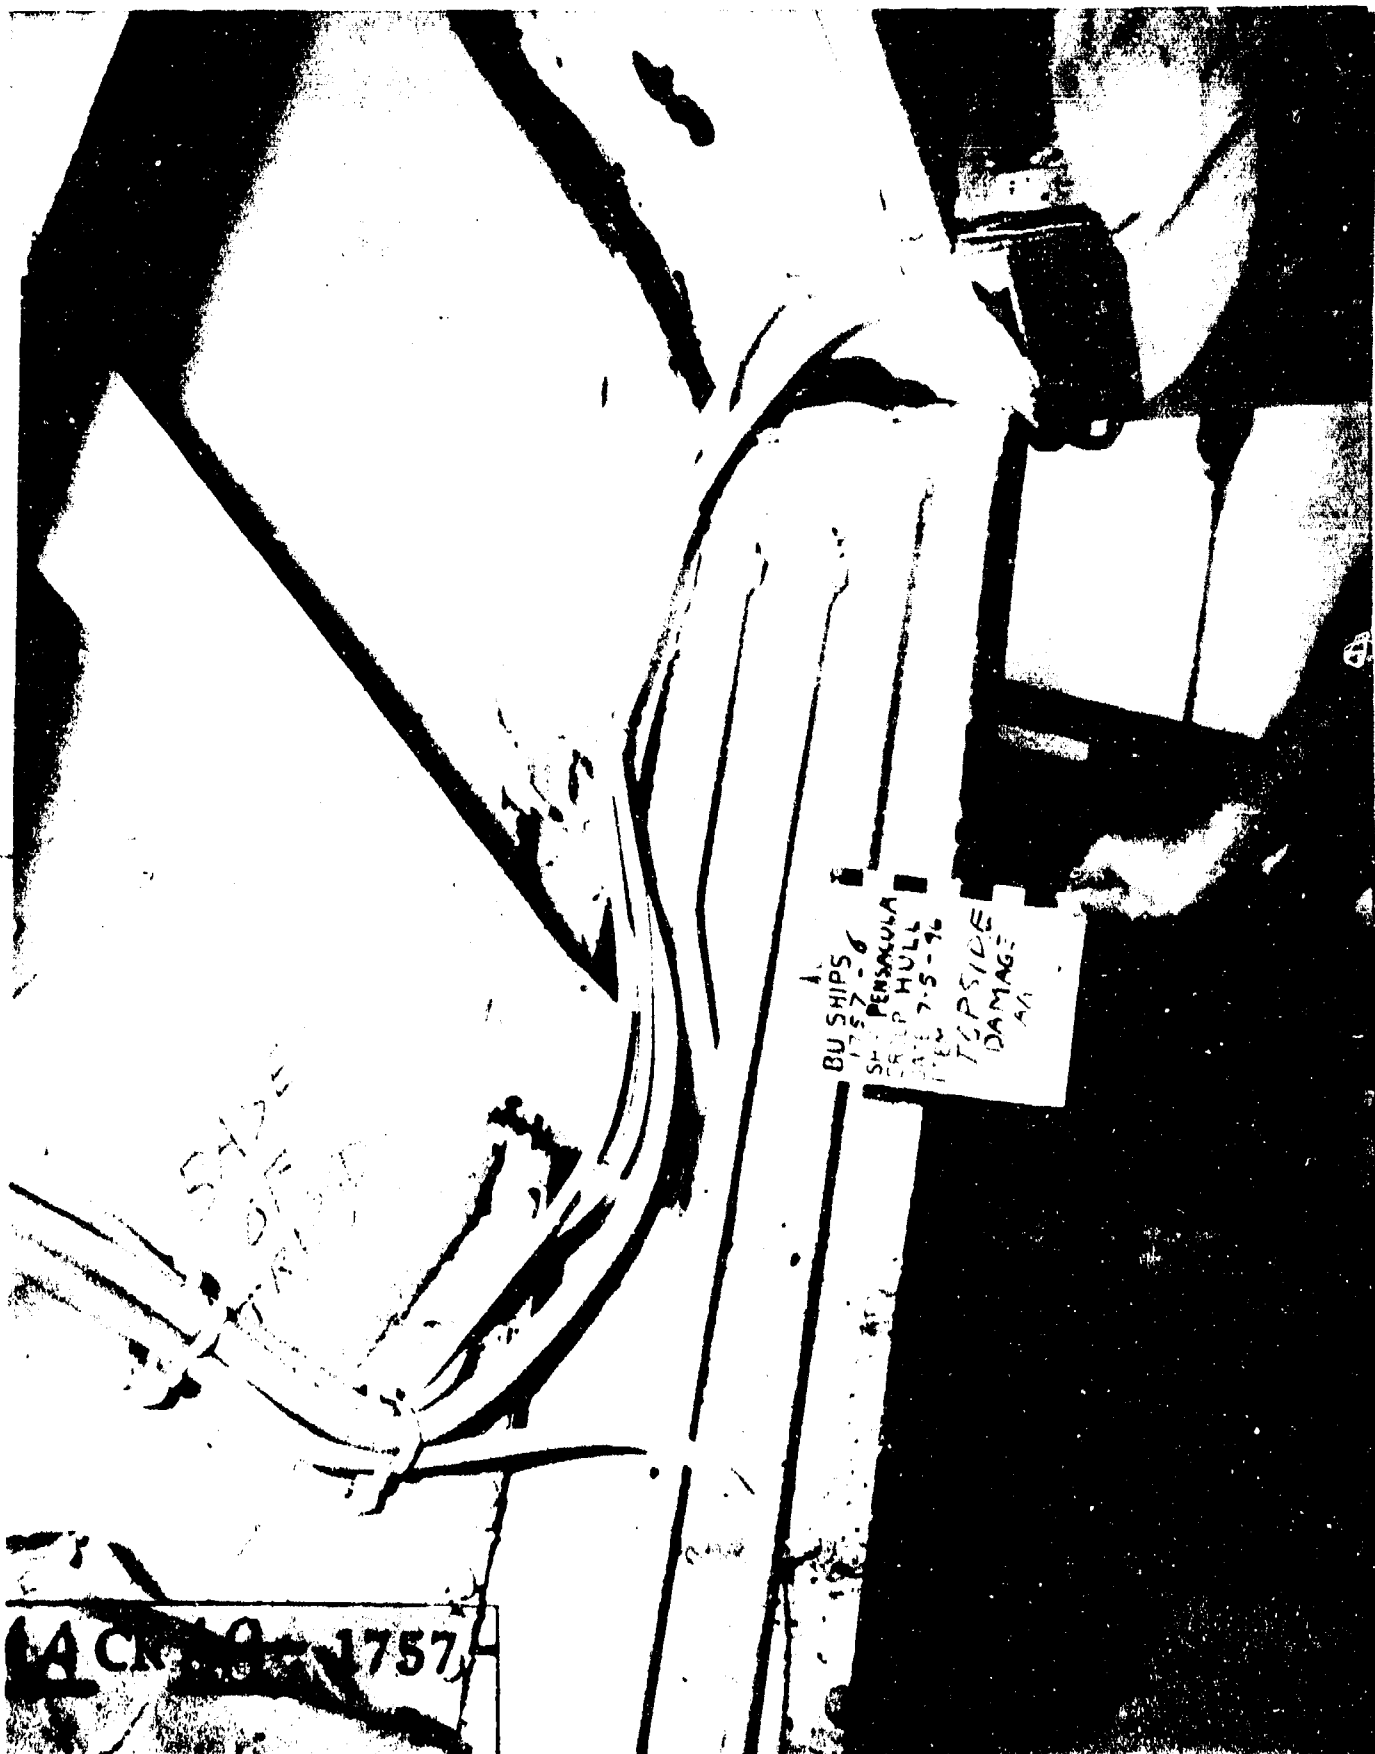
AA-CR-68-1757-6. U.S.S. PENSACOLA (CA24). Looking up at under side of 01 deck showing base of port after leg of mainmast strut - frame 92.

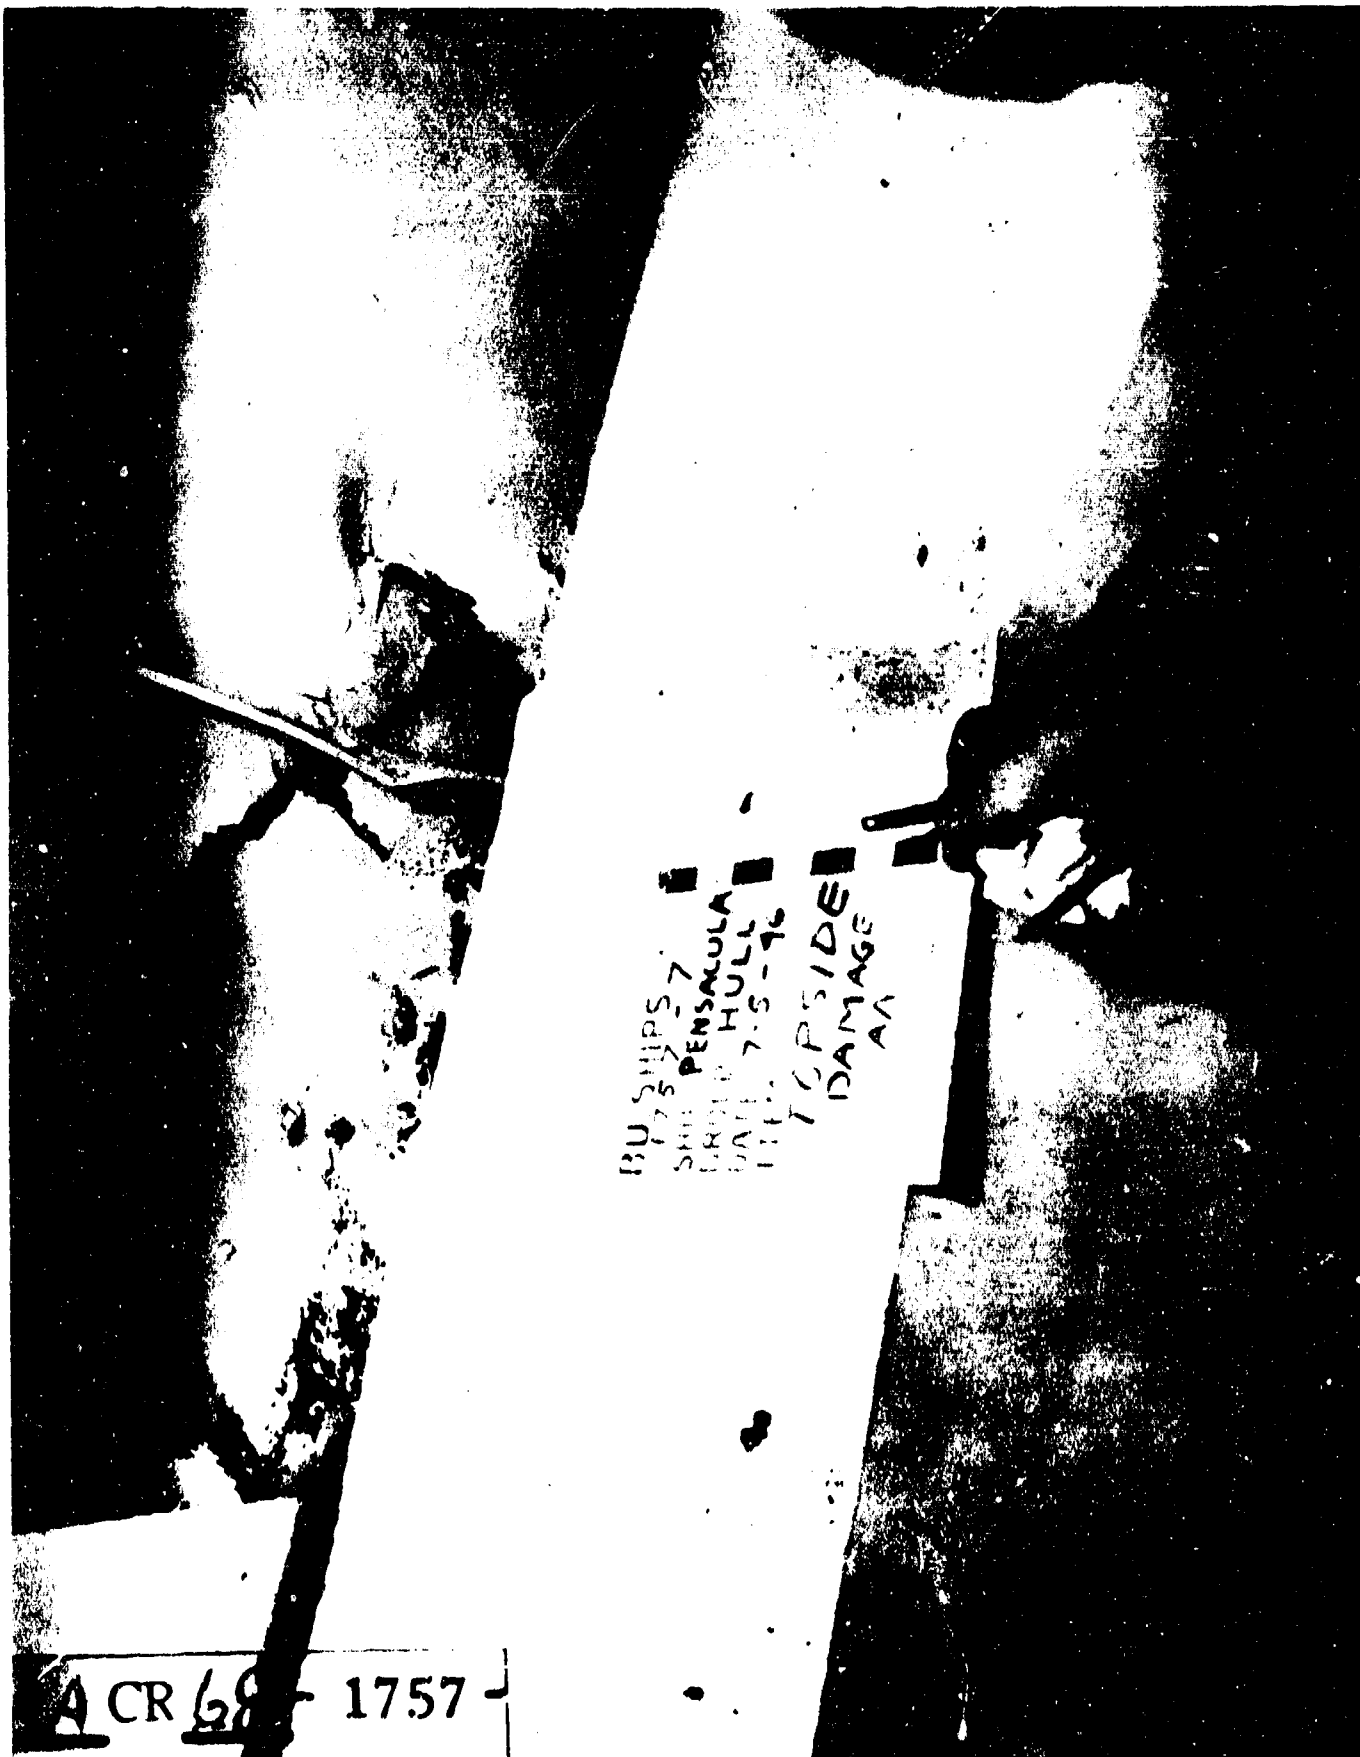
AA-CR-68-1757-7. U.S.S. PENSACOLA (CA24). Looking up at underside of 01 deck showing base of starboard after leg of mainmast strut-frame 92.

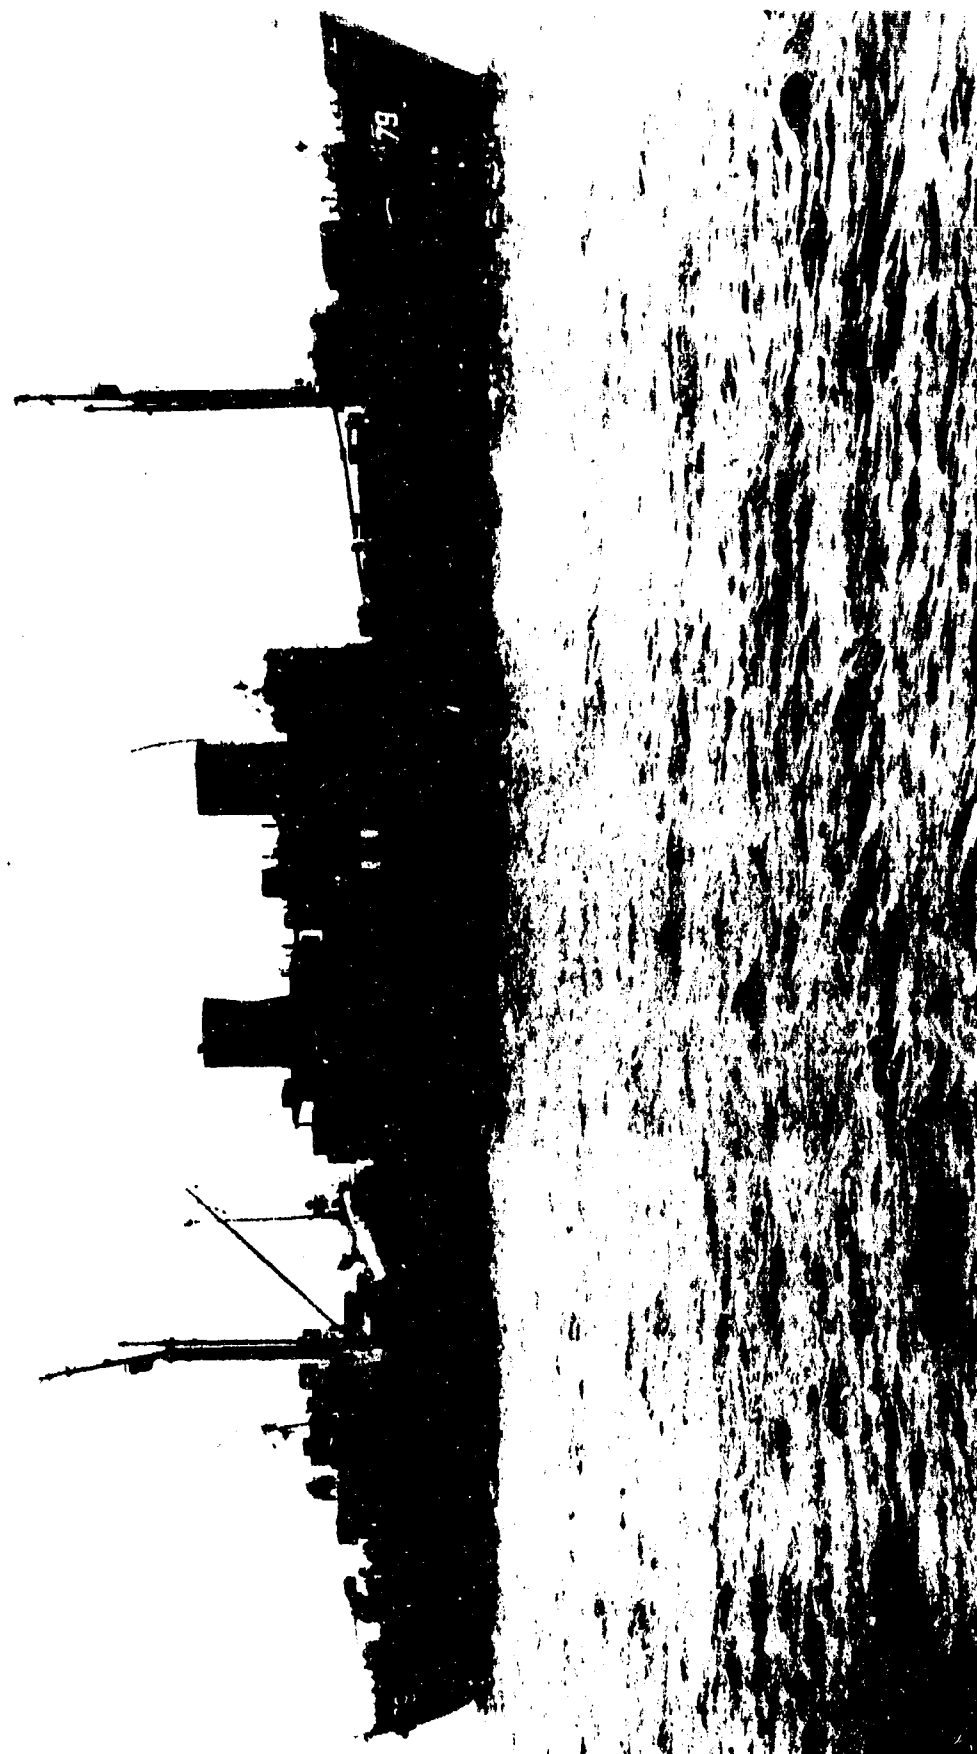
AA-CR-227-87-64. U.S.S. DAWSON (APA 79). View looking at starboard beam after Test A.

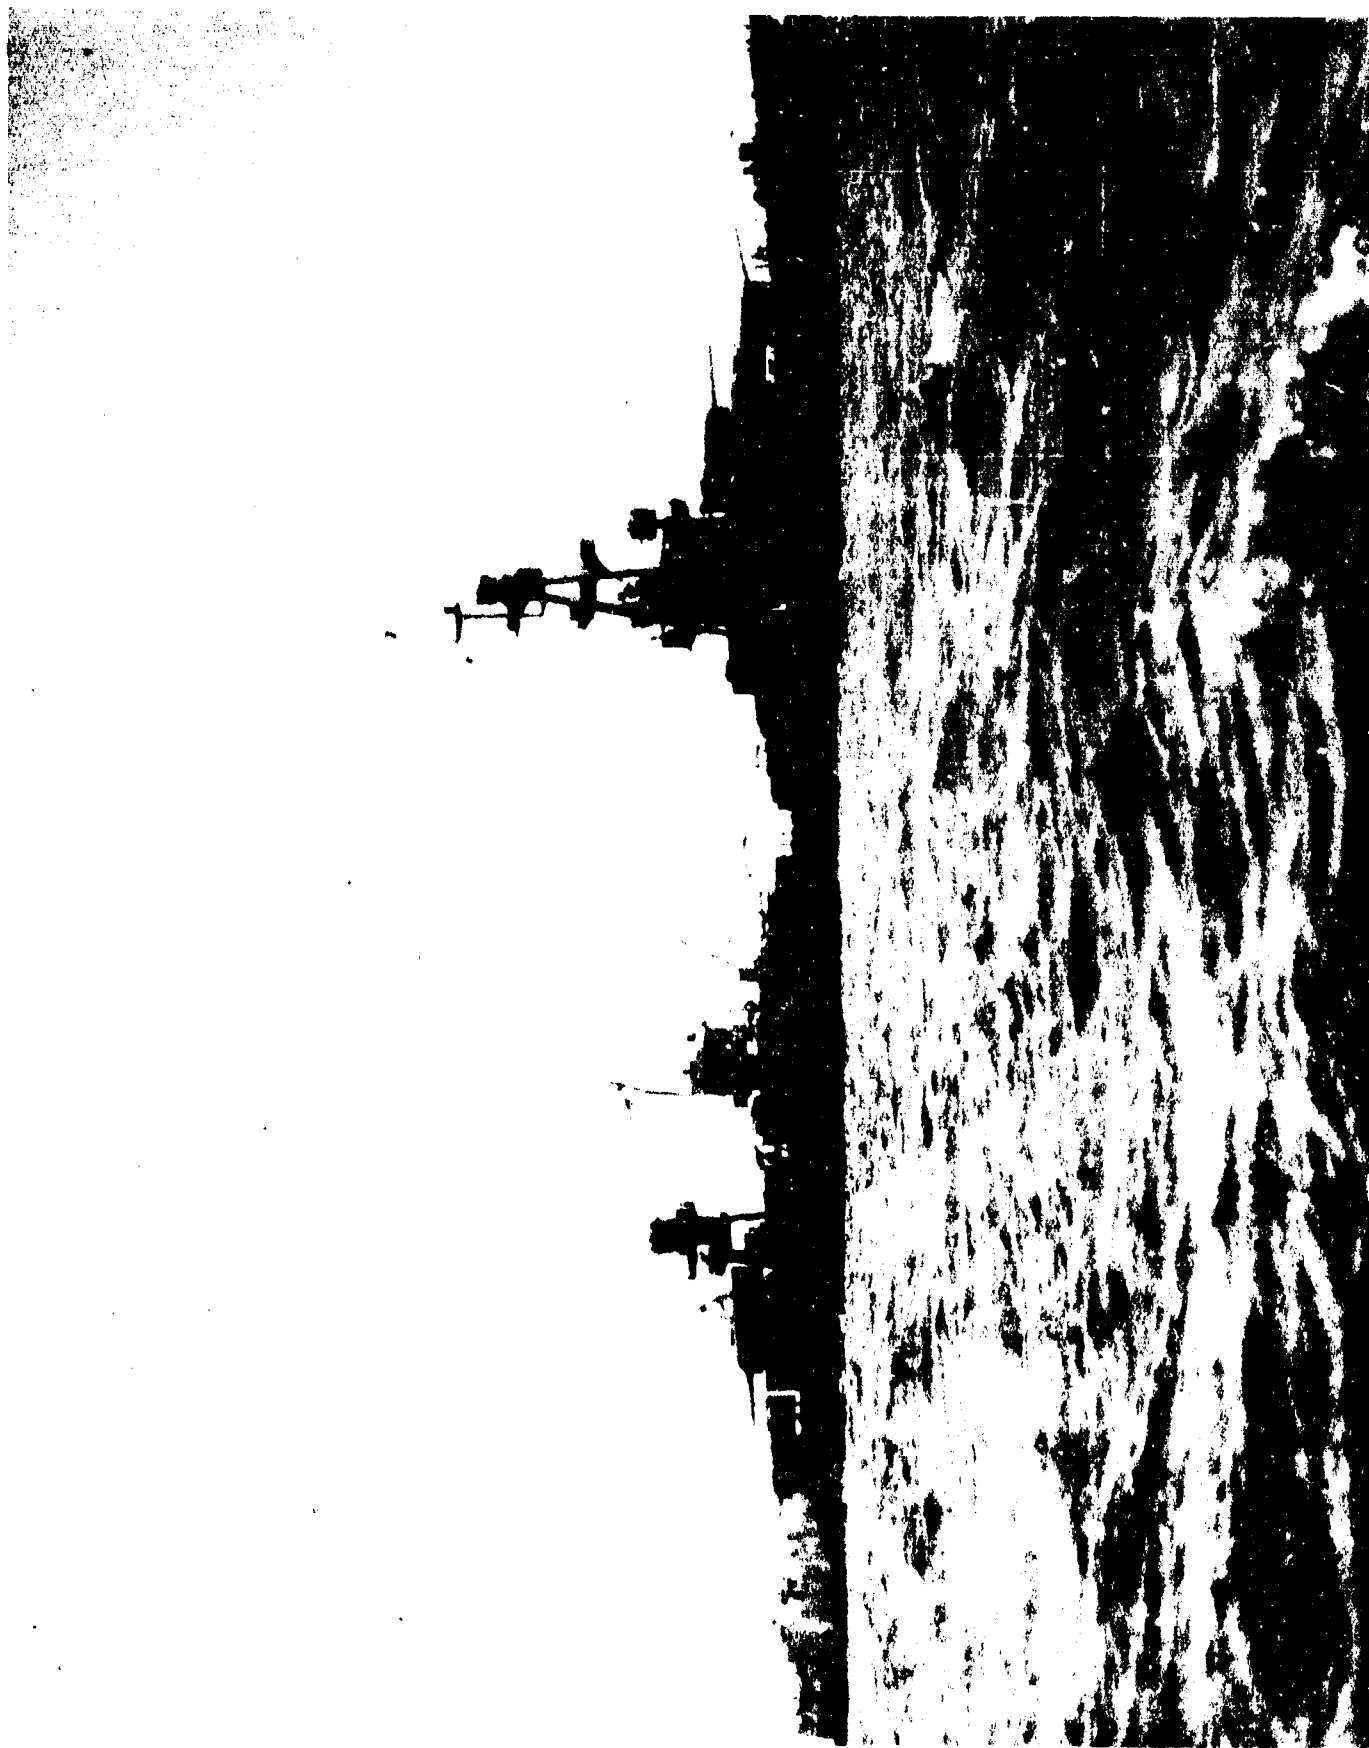
AA-CR-227-91-47. U.S.S. SALT LAKE CITY (CA25). View looking at starboard beam after Test A.

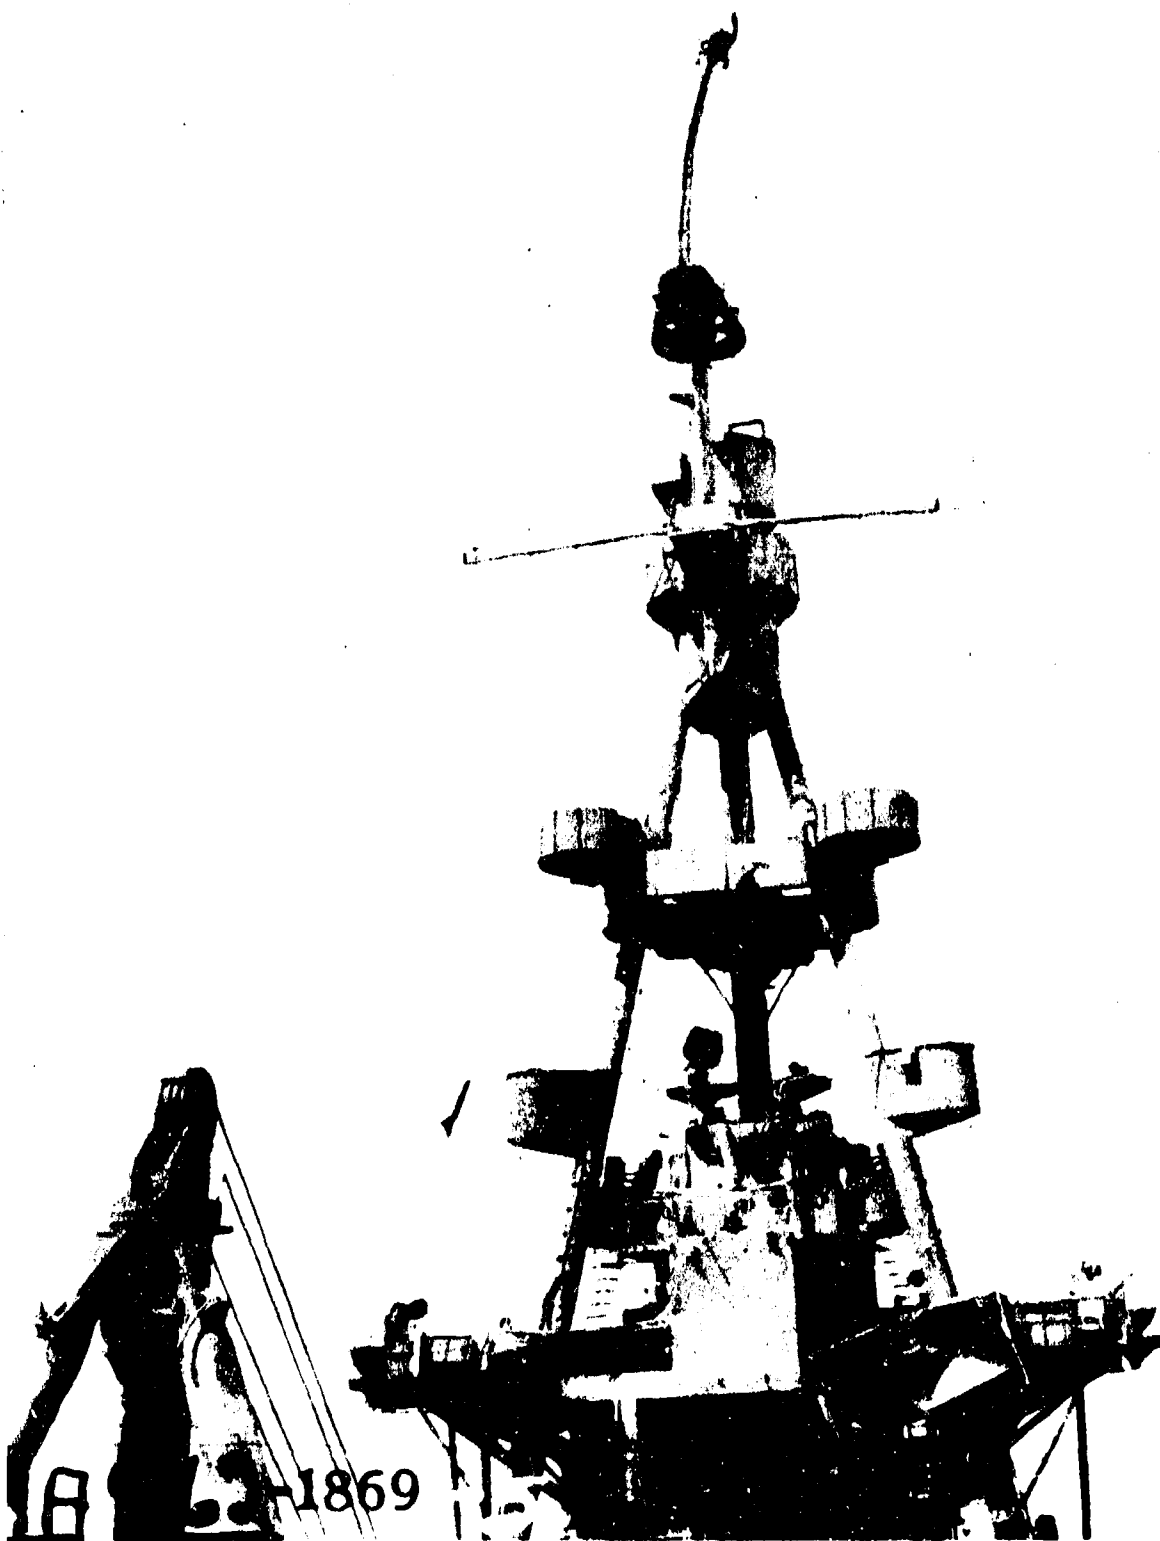
AA-CR-62-1869-5. U.S.S. SALT LAKE CITY (CA25). Looking forward at top of forward tripod and radar polemast from frame 74.

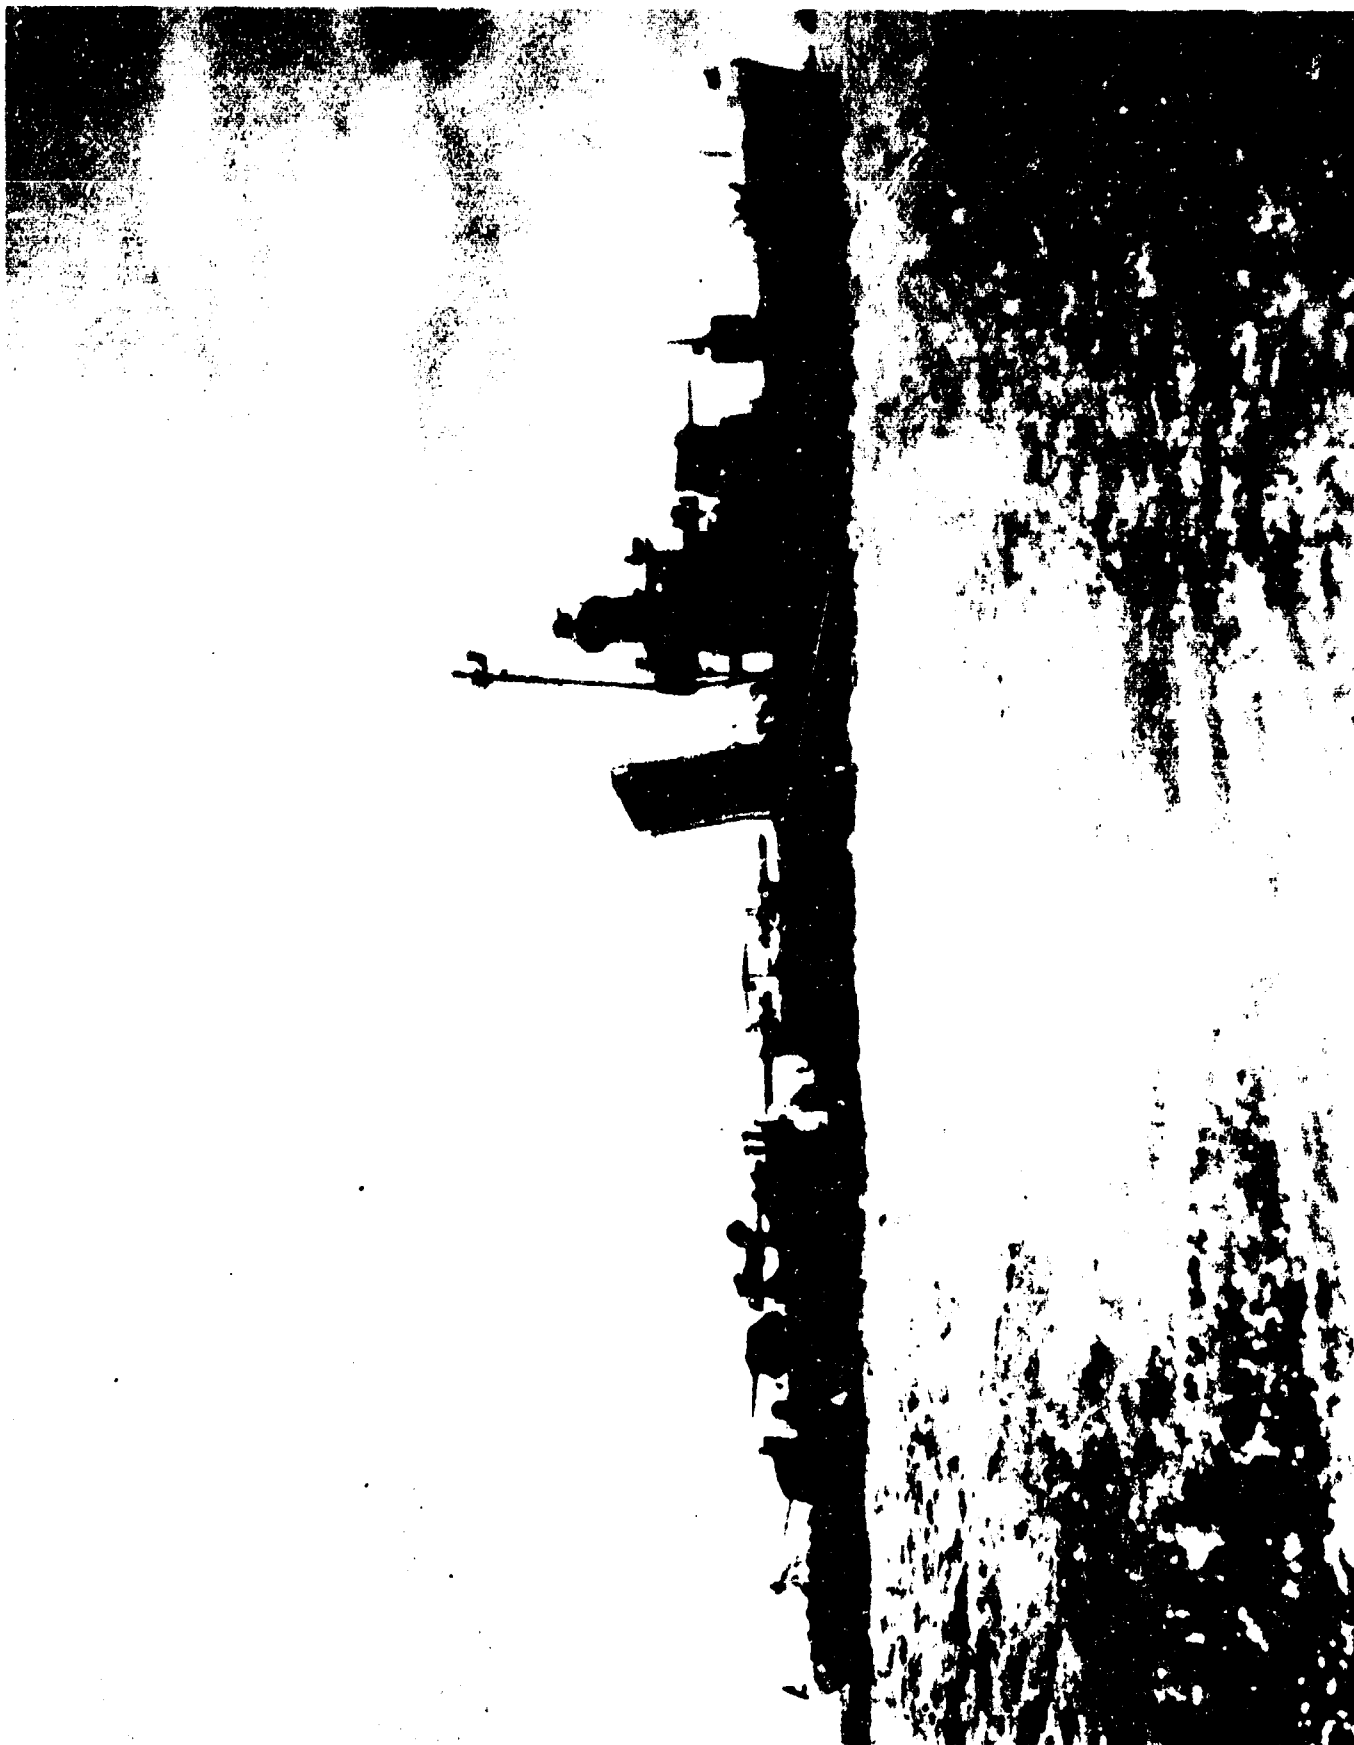
BB-CR-227-513-11. U.S.S. HUGHES (DD410). View looking at starboard beam after Test Able.

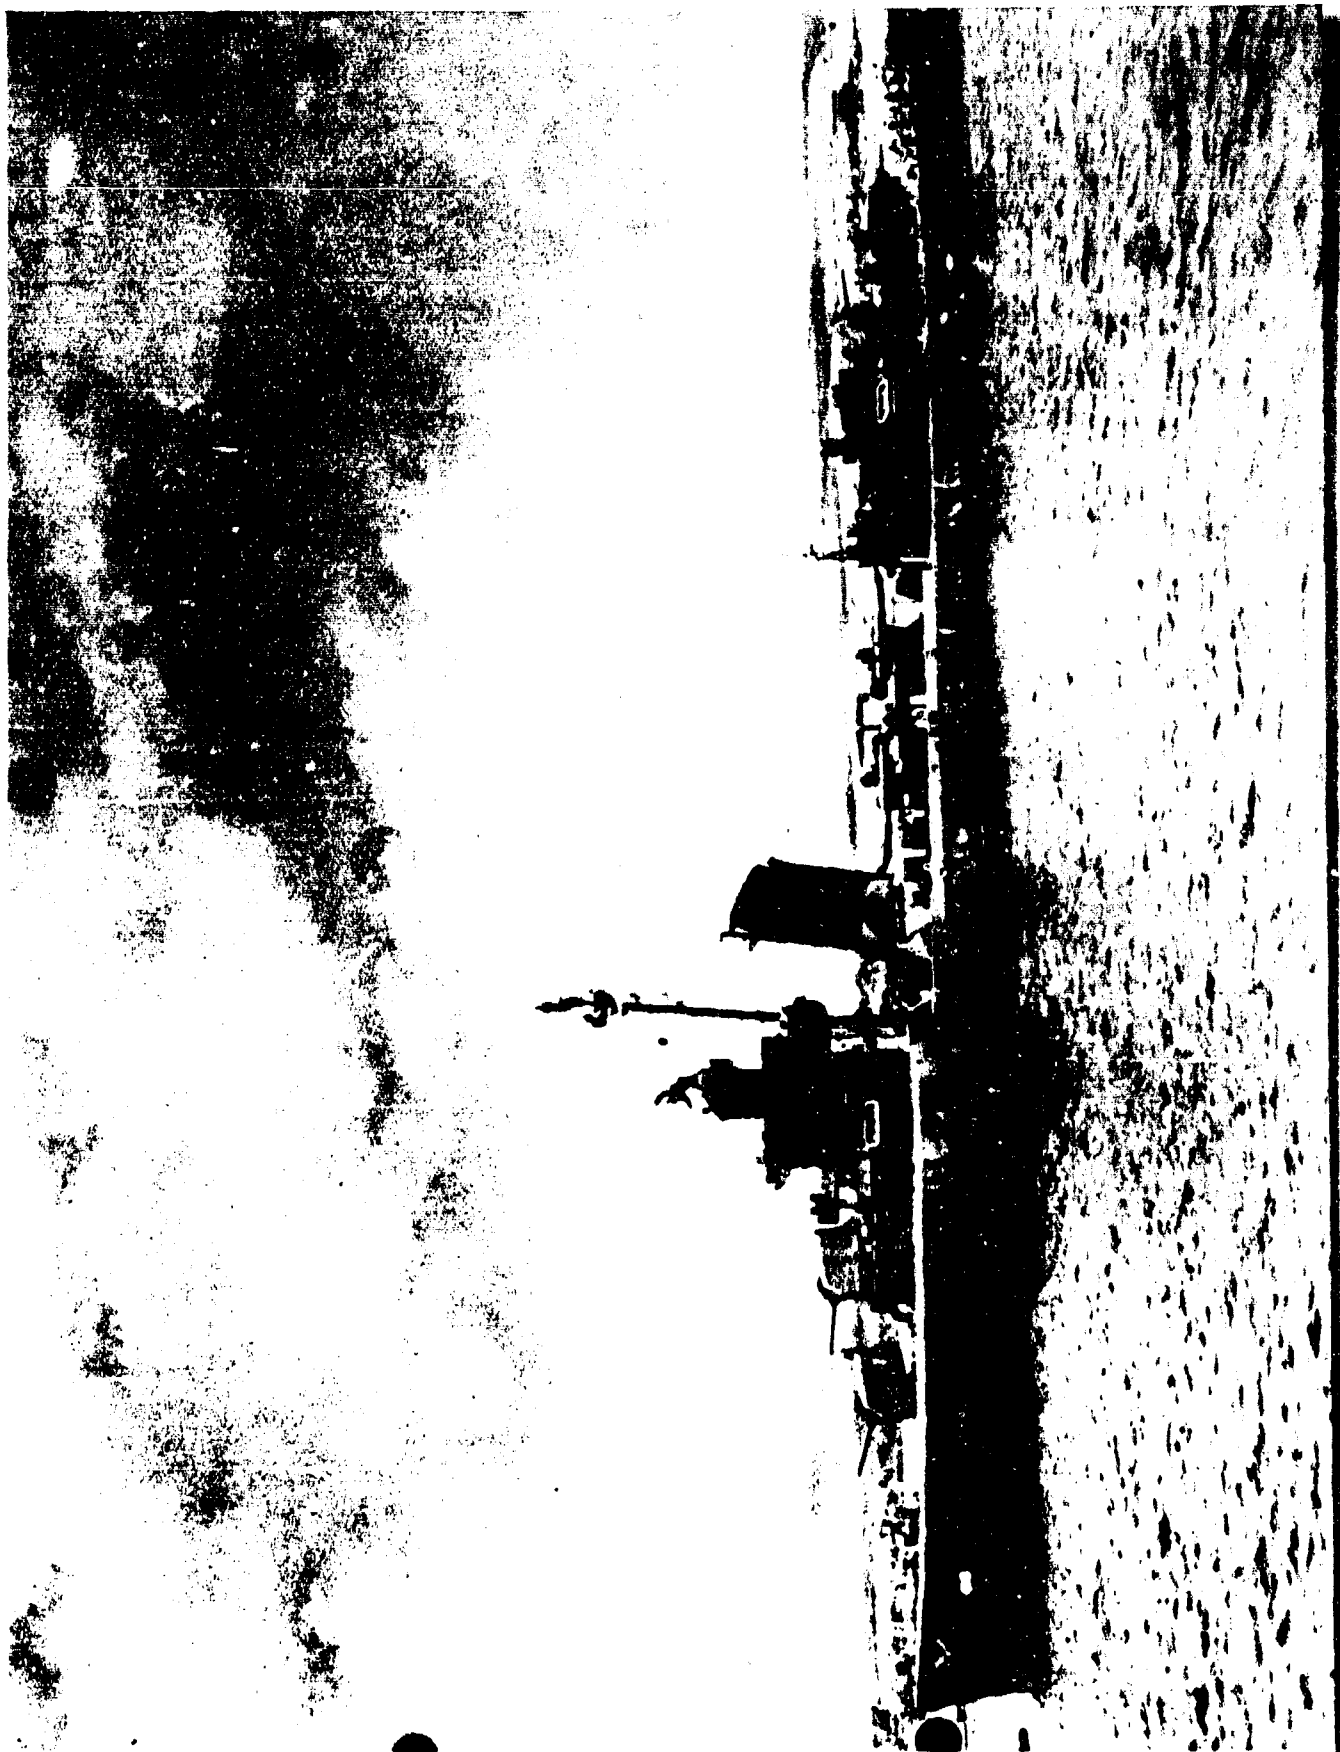
BuShips #114020. U.S.S. HUGHES (DD410). View looking at port beam before Test Able.
